ANNUAL REPORT FOR 2005

Michael's Branch Mitigation Site
Alamance County
TIP No. U-3110A

Prepared By:
Natural Environment Unit & Roadside Environmental Unit
North Carolina Department of Transportation
December 2005

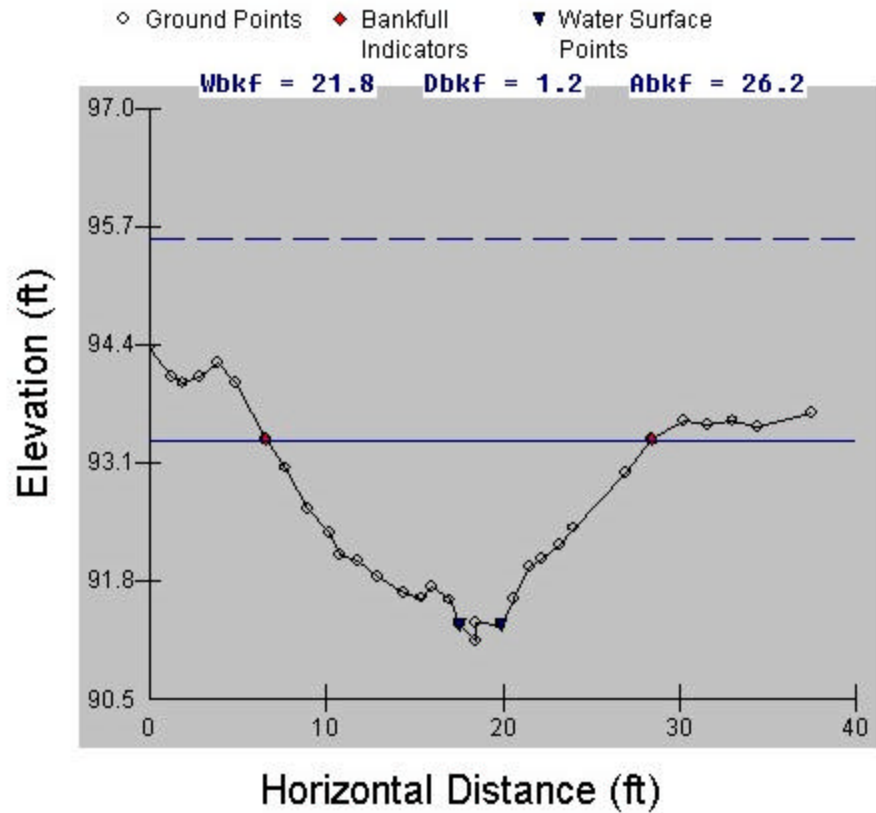
Riffle Cross Section #1

Based on comparisons of design cross section data and Year 2005 monitoring data, both cross sections appear stable with little or no active bank erosion.
